LPT50BRD

(8x8x4 Enclosure)

TROUBLESHOOTING AND REPAIR MANUAL

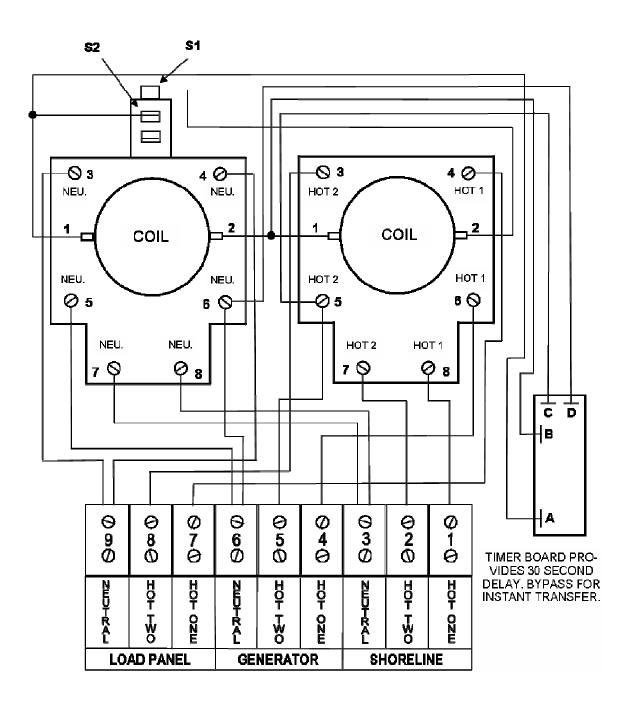
LPT50BRD Wiring Diagram

- **A.** From the terminal block Shoreline Neutral location (3) to the NEUTRAL relay location #8 and #7 (2 -10 AWG WHITE wires)
- **B.** From the terminal block Shoreline Hot Two location (2) to the HOT relay location #8 (single 10 AWG BLACK wire)
- **C.** From the terminal block Hot One location (1) to the HOT relay location #7 (single 10 AWG BLACK wire)

- **A.** From the terminal block Generator Neutral location (6) to the relay location #6 and #5 (2-10 AWG WHITE wires).
- **B.** From terminal block Generator Hot Two location (5) to the HOT relay location #6 (single 10 AWG BLACK wire)
- **C.** From terminal block Generator Hot One location (4) to the HOT relay location #5 (single 10 AWG BLACK wire)

- **A.** From terminal block Load Panel Neutral location (9) to the NEUTRAL relay location #4 and #3 (2 -10 AWG WHITE wires).
- **B.** From terminal block Hot Two location (8) to the HOT relay location #4 (single 10 AWG BLACK wire).
- **C.** From terminal block Hot One location (7) to the HOT relay location #3 (single 10 AWG BLACK wire)

- **A.** One wire of a double wire set is connected from point A on the time delay pc board to point S2 on the auxiliary switch located on the back of the NEUTRAL relay. The second wire from the set is connected from S2 to terminal # 1 on the NEUTRAL relay.
- **B.** A single wire from point \$1 on the auxiliary switch connects to terminal #2 on the HOT relay.
- **C.** One wire of another double set connects point B on the time delay pc board to terminal #2 on the NEUTRAL relay. The second wire from the set connects terminal #2 on the NEUTRAL relay to terminal #1 on the HOT relay.
- **D.** A single wire from terminal C on the time delay pc board to terminal #5 of the HOT relay.
- **E.** A single wire from terminal D on the time delay pc board to terminal #6 of the NEUTRAL relay.

Disconnect shore cord, turn breakers off at the generator and disconnect the inverter if installed. Remove the lid from the enclosure and check for AC voltage at all terminals to be sure that power is disconnected. Refer to the wiring diagram at the end of this manual for test points. Check connections to make sure all wires are secured and not broken off or burned. Be sure there is no debris inside enclosure.

- A. WARNING: HAZARDOUS VOLTAGES. If the transfer switch does not switch to generator power within 90 seconds of generator startup, check for proper AC voltage input using an AC voltmeter. Refer to the wiring diagram below. The screws on the terminal block are a good point to test for these voltages. Use the numbers on the terminal block or the label placed in front of the block to locate the generator NEUTRAL (6), HOT ONE (4) and HOT TWO (5) points. The meter should read 90 to 120VAC between generator NEUTRAL & HOT ONE and generator NEUTRAL & HOT TWO. For 120 VAC generator input, HOT ONE should be jumpered to HOT TWO.

- **D.** If the green LED did light, and the switch does not transfer from shore power to generator power, then check the DC coil voltage on each relay. Set the DC voltmeter to the 200 VDC, or equivalent, range. With the terminal block facing the bottom of the enclosure, the NEUTRAL relay is on the left and the HOT relay is on the right. Individually check each relay at terminals 1 and 2. The voltmeter should read between 105 and 170 VDC. If it does not, replace the time delay pc board.

- If the proper DC voltage was present in the previous step, check the coil resistance using an Ohmmeter. **MAKE SURE ALL POWER COMING INTO THE TRANSFER SWITCH IS OFF.** Refer to the wiring diagram below. Individually check each relay at terminals 1 and 2. The resistance of each coil should be in the 5.5 K ohm to 6.5K ohms range. If either relay fails the resistance check, replace that relay.

To check the switch, refer to the wiring diagram and connect an Ohmmeter to the wires coming from points \$1 and \$2. Push down on the armature of the NEUTRAL relay. The Ohmmeter should read close to zero Ohms. Release the armature so the NEUTRAL relay returns to the normally closed state. The Ohmmeter should read open circuit. If the auxiliary switch does not have continuity when the NEUTRAL relay armature is pushed down, then it is either out of alignment or does not work properly.

Refer to the drawing at the end of this document.
